Manhole Inspection Summary

Manhole # S29GG1022MH

Insp Date: **2/20/07 2:36 PM**

Location Address: **501 UNIVERSITY PKWY**

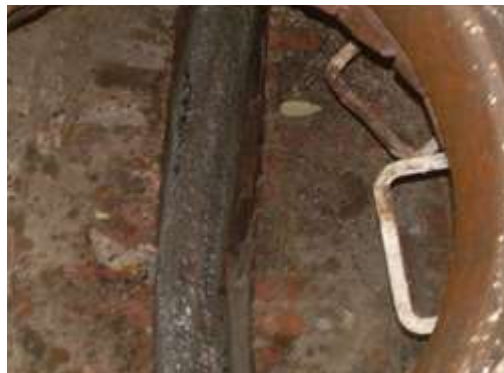
Top View

Frame leaks. Corbel infiltration. Corroded steps. Bench debris.

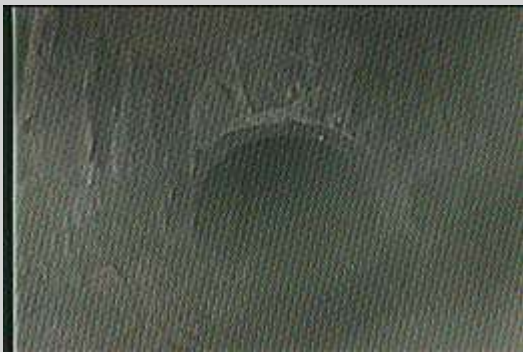
8 in. Circular Gravity Sewer Pipe Out @ 12 O'Clock

Pipe Material: **Clay** ☐ Pipe Lined

Invert Depth: **6.75** (ft.) Flow Characteristics: **Fast**

Deposits: ☒ None ☐ Mud ☐ Sludge ☐ Debris ☐ Grease

Infiltration: **None** Pipe Seal Cond: **Unknown**

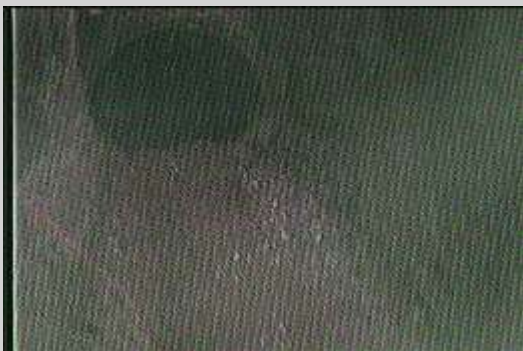
8 in. Circular Gravity Sewer Pipe In @ 5 O'Clock

Pipe Material: **Clay** ☐ Pipe Lined

Invert Depth: **6.12** (ft.) Flow Characteristics: **Fast**

Deposits: ☒ None ☐ Mud ☐ Sludge ☐ Debris ☐ Grease

Infiltration: **None** Pipe Seal Cond: **Unknown**
